DEPARTMENT OF TRANSPORTATION

Quality Assurance and Source Inspection

Contract #: 04-0120F4Cty: SF/ALA Rte: 80 PM: 13.2/13.9File #: 13.28**WELDING INSPECTION REPORT****Resident Engineer:**Pursell, Gary**Address:** 333 Burma Road**City:** Oakland, CA 94607**Report No:** WIR-007958**Date Inspected:** 27-Jul-2009**Project Name:** SAS Superstructure**OSM Arrival Time:** 700**Prime Contractor:** American Bridge/Fluor Enterprises, a JV**OSM Departure Time:** 1530**Contractor:** Oregon Iron Works Clackamas, Or.**Location:** Clackamas, OR**CWI Name:** Mike Gregson, Jose Salazar**CWI Present:** Yes No**Inspected CWI report:** Yes No N/A**Rod Oven in Use:** Yes No N/A**Electrode to specification:** Yes No N/A**Weld Procedures Followed:** Yes No N/A**Qualified Welders:** Yes No N/A**Verified Joint Fit-up:** Yes No N/A**Approved Drawings:** Yes No N/A**Approved WPS:** Yes No N/A**Delayed / Cancelled:** Yes No N/A**Bridge No:** 34-0006**Component:** Hinge K Pipe Beams**Summary of Items Observed:**

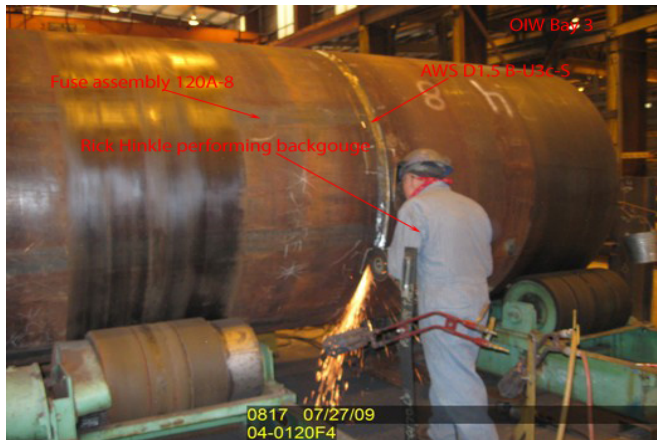
Hinge-K Pipe Beam Fuse Assembly 120A-1: 7/27/09

a124-6 Half Fuse to a124-7 Half Fuse

QA Inspector noticed that the first ESW stainless steel overlay passes were 100% complete and this fuse assembly 120A-1 was sitting idle. QA Inspector noted the first layer passes were completed utilizing the 309L consumable strip and the remaining second & third layer passes would be completed utilizing Soudokay brand Soudotape 316L stainless steel consumable strip, per contract requirements. See attached picture below.

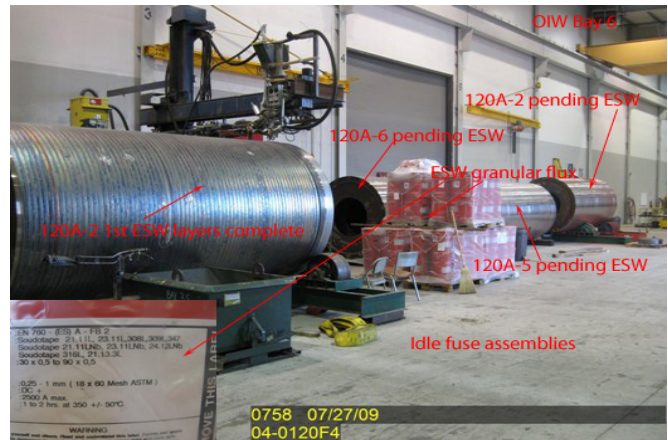
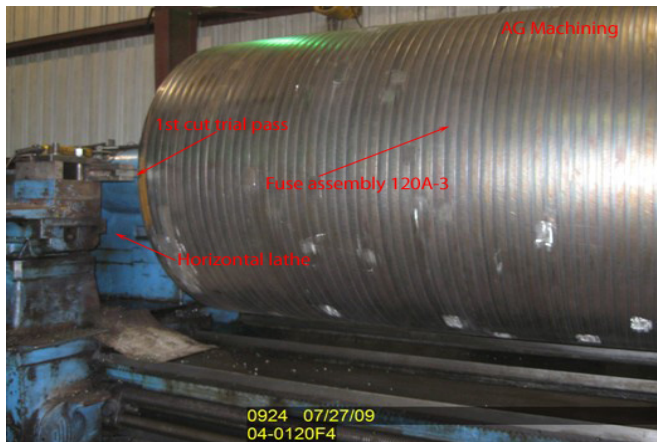
Hinge-K Pipe Beam Fuse Assembly 120A-3: 7/27/09

a124-12 Half Fuse to a124-10 Half Fuse

QA Inspector arrived at AG Machining, on this date and noticed that OIW had previously transferred this fuse assembly 120A-3 to AG Machining and the 1st machining cut pass was in-process. QA Inspector spoke with AG Machinist and AG explained that end result machining would continue, to a finished outside diameter measurement of 1925mm, per OIW Project Manager Bill Pender. See attached pictures below.

Note: QA Inspector noted that AG was in-process of performing "trial" machining on this fuse assembly 120A-3. After the "trial" machining is completed, this fuse assembly 120A-3 will be transferred back to OIW and OIW QC Inspectors will perform preliminary inspections on the ESW weld passes. OIW will then perform any necessary welding/grinding repairs on the overlay, prior to final machining by AG. Once accepted by OIW, this fuse assembly 120A-3 will be eventually transferred back to AG Machining and AG will machine a final outside diameter of 1920mm (+/- 1mm), per contract requirements and OIW approved drawings.
